## **PHASE 2: GROUND INVESTIGATION REPORT**

### **LAND NORTH OF HOLME HOUSE RESIDENTIAL HOME**

### **OXFORD ROAD**

**Project No: 17-174**

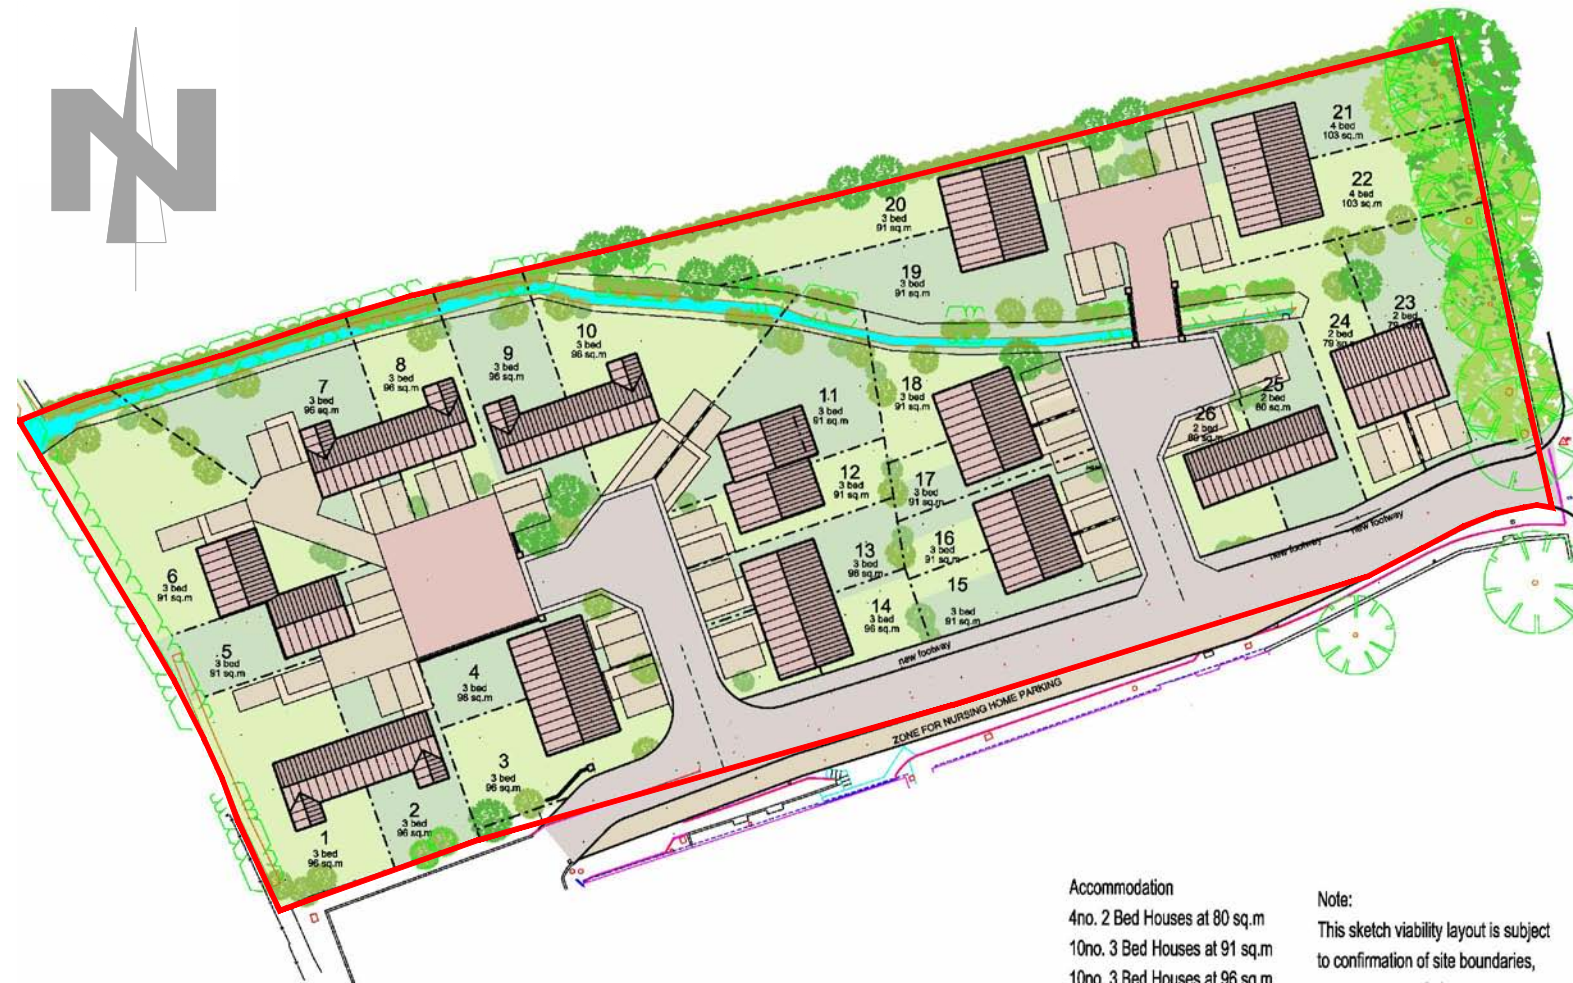
Accommodation  
 4no. 2 Bed Houses at 80 sq.m  
 10no. 3 Bed Houses at 91 sq.m  
 10no. 3 Bed Houses at 96 sq.m  
 2no. 4 Bed Houses at 103 sq.m  
 26no. Total

PREFERRED LAYOUT  
 OPTION TO BE CONFIRMED

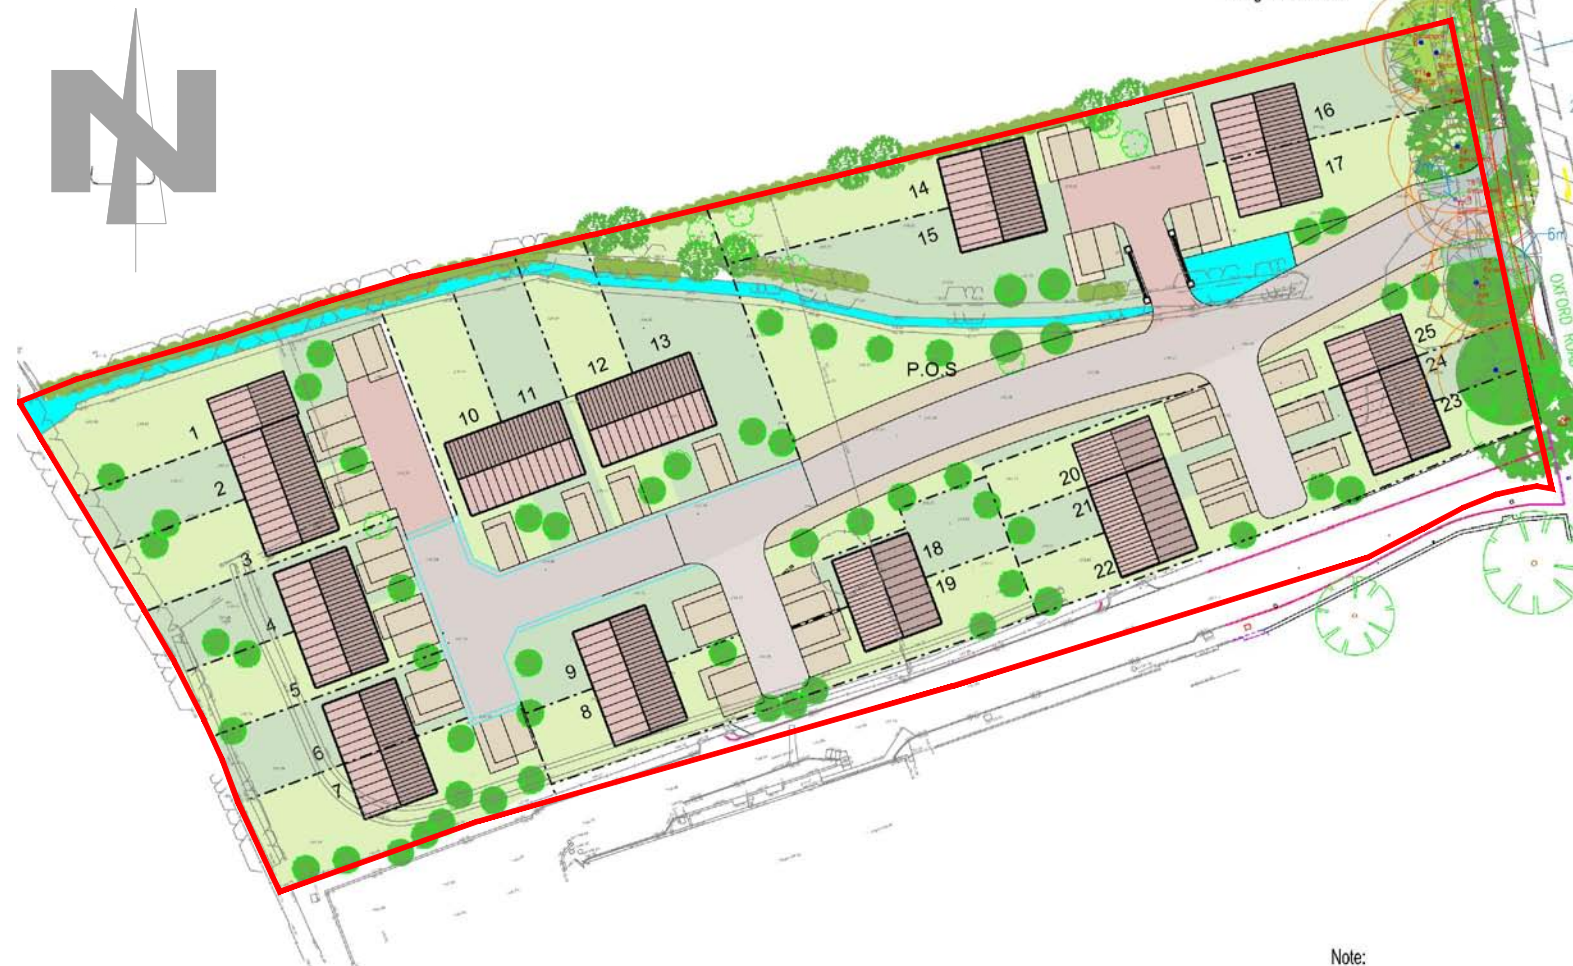
Note:  
 This sketch viability layout is subject to confirmation of site boundaries, easements, restrictive covenants etc; consultation with Local Authority, Public Utilities etc.

Accommodation  
 8no. 2 Bed Houses
